Number
FALLING SPRINGS DAM

NDS ID ~~NO~~ PA-00372,

Susquehanna River Basin, Falling Springs
Creek, Lackawanna County, Pennsylvania.

PHASE I INSPECTION REPORT.

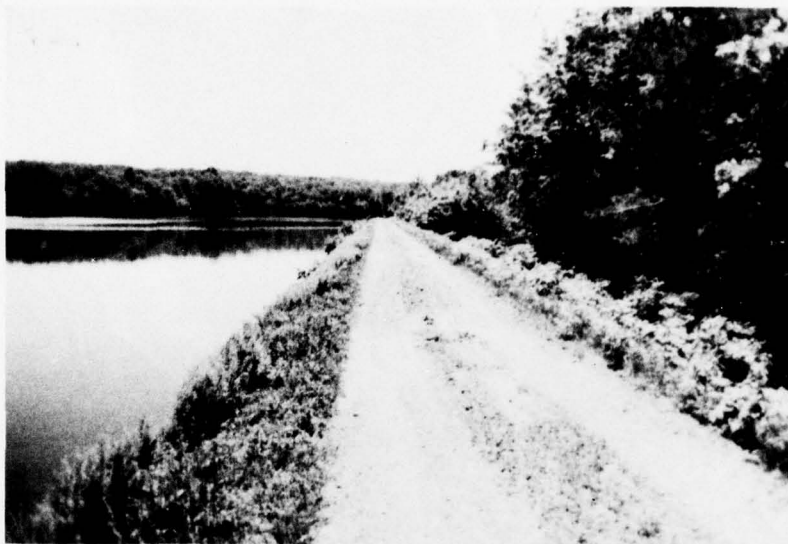
(1) Main Embankment. The main embankment was generally in good condition from what could be seen. However, brush and young trees with an average height of about 12 feet were growing on the downstream slope of the embankment and hindered the inspection. The growth was quite dense in places, with the diameter of the trees varying to up to 3 inches. Results of the survey of the downstream slope indicate that the slope varies slightly, but not significantly, from the design slope of 1V on 2H. A fallen 50-foot tree was decaying on the slope. There was a row of mature evergreen trees that were spaced at about 12-foot intervals at the toe of the embankment. Several trees of about 12-foot height and 4-inch diameter were grouped near the junction of the main embankment with the left end of the spillway. The riprap on the upstream face of the main embankment is generally in place and is in good condition. There is a general cover of light brush about 18 inches in height on the upstream slope above the normal pool elevation.

There were two wet areas at the downstream toe of the main embankment near the left abutment. The first wet area was the result of seepage through a 40-foot by 100-foot portion of the vertical rock face immediately downstream of the left abutment. The seepage was collected by a rock-lined channel and joined the flow from the outlet channel about 180 feet downstream. The seepage was clear, and the flow in the rock-lined channel was about 5 to 10 gpm. The second wet area was observed about 20 feet to the right of the rock-lined channel and

A. Main Embankment
View from Right Abutment

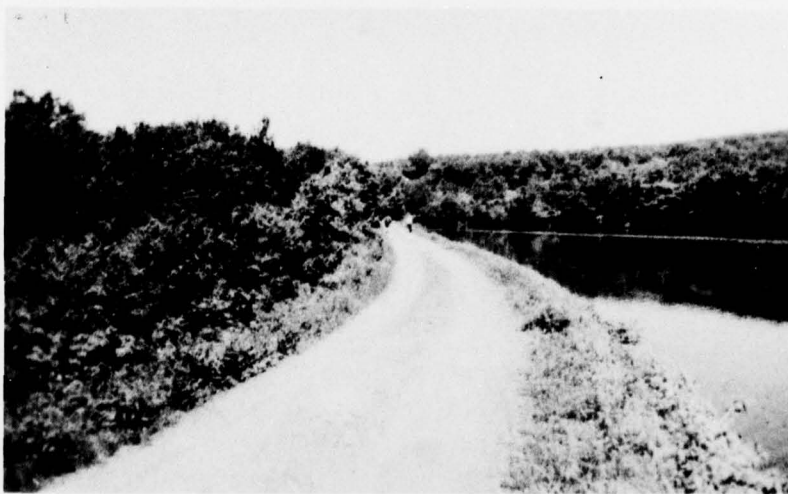
B. Main Embankment
View from Left Abutment

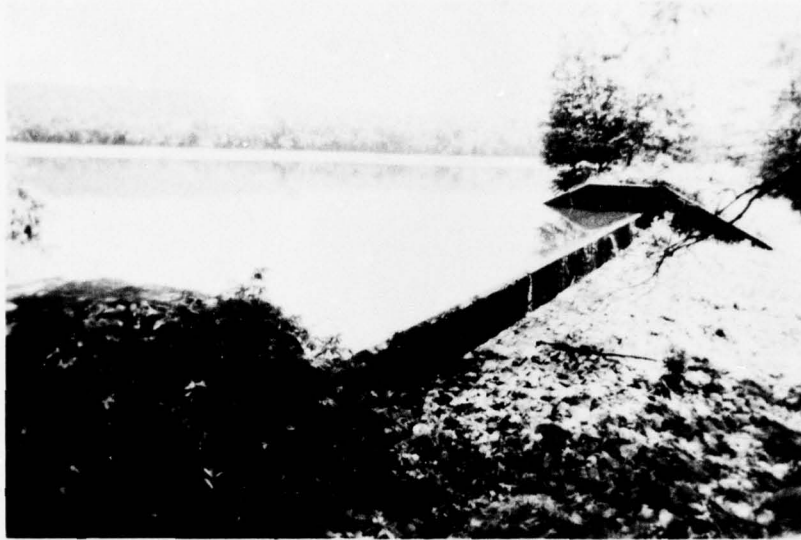
(1) Spillway. In general, the concrete of the spillway weir and spillway abutments was in satisfactory condition. Since water was flowing over the spillway crest, the downstream face of the spillway weir could not be closely inspected. It was observed, however, that moss was growing on the face and that coarse aggregate was exposed in several places across the face and crest. Concrete was spalled to an average distance into the reservoir of about 9 inches and to an average vertical depth of about 10 inches at three locations across the spillway crest. Two of the spalled areas were at the monolith joints. The joint filler was missing where the concrete was spalled at the joints. The third area of spalling was at a transverse or shrinkage crack 10 feet from the right abutment. Two other transverse or shrinkage cracks were noted in the spillway weir. In general, the cracks were parallel with the flow and ran upstream for a distance of about 2 feet until observation was obstructed by the water in the reservoir. The cracks were about 1/4 inch wide and were probed to a depth of about 1/4 inch. No differential movement was noted at the cracks. Three small spalled areas and a small crack were observed on the spillway right abutment wall. The spalled areas were, on the average, about 5 inches wide, 6 inches long, and 3 inches deep. The vertical crack ran from the spillway crest to the top of the abutment wall. The crack was probed to a depth of about 1/4 inch. No differential movement was noted at the crack. There appeared to have been an attempt to patch the crack at one time.

(1) Spillway. The condition of the concrete of the spillway weir and spillway abutments is of slight concern at the present time. Additional spalling and surface cracking of the concrete could become more of a concern in the future. The spalling at the joints of the spillway weir could reduce the ability of the weir to act as a watertight structure.

C. Spillway

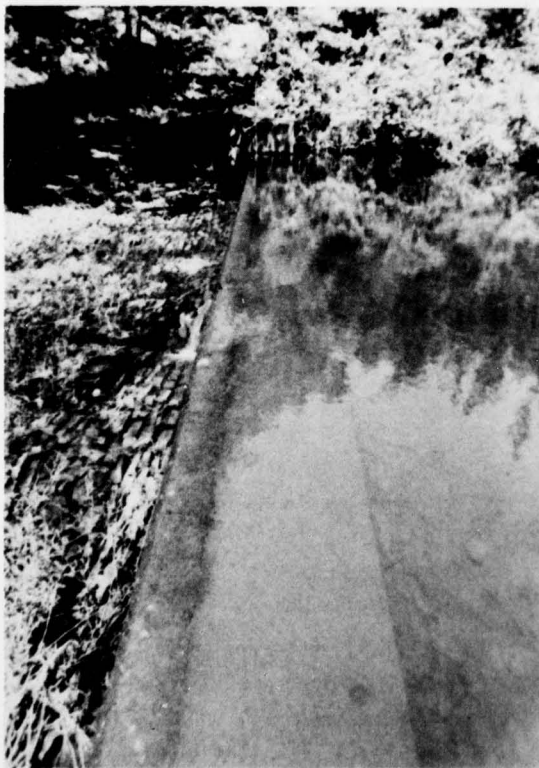
D. Spillway Crest

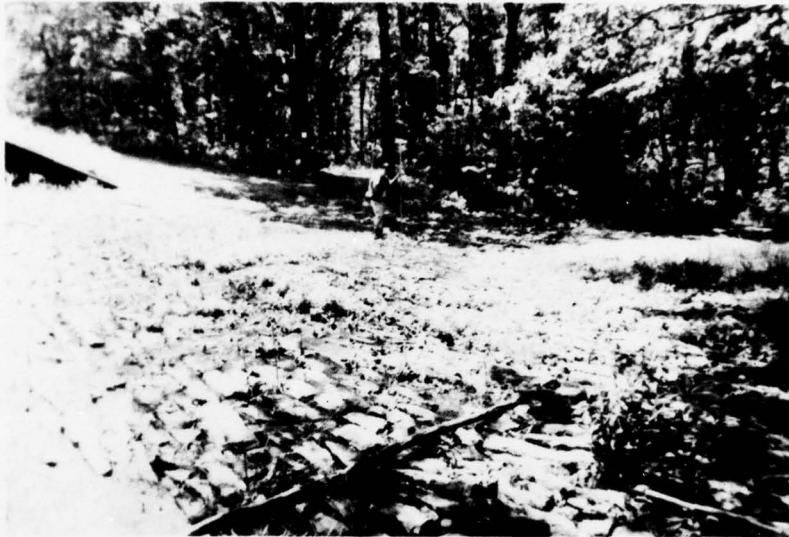
The spillway apron was generally in good condition. Grass was growing through the riprap cover over about 50 percent of the spillway apron. A 3-foot by 3-foot brush area was observed 2 feet downstream of the spillway weir. Minor debris had collected on the spillway apron. At the downstream end of the spillway apron, the channel invert drops 6 feet, nearly vertical, onto boulders, smaller rocks, and an earthen channel composed

The conditions of the approach channel and the spillway apron are of little concern, although the debris, brush, and grass present are undesirable. There is general concern for the condition at the downstream end of the spillway apron, where the channel invert drops nearly vertical for a distance of about 6 feet. During larger discharges, considerable scouring could occur that might undermine the riprap apron and threaten the toe of the main embankment and the spillway.

E. Spillway Apron

(9) Investigate scour damage that could occur during periods of high discharge at downstream end of spillway apron.

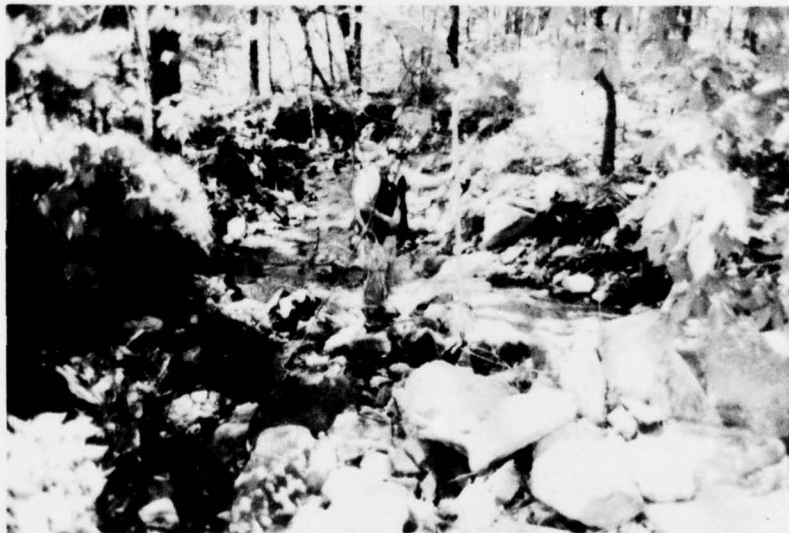
e. Downstream Channel. The channel immediately below the spillway is roughly rectangular in shape and is composed of a hard clay and loose rocks and boulders. The slope of the channel is steep. At the time of the inspection, the flow in the channel below the spillway was about 3 cfs. The channel appeared to have been undergoing degradation for many years. A wooded area of hardwoods and evergreens starts immediately below the spillway apron. Some trees extend to the immediate overbanks of the channel. Flow from the spillway joins the flow from the outlet works about 0.25 mile downstream of the dam.

F. Downstream Channel from Edge of Spillway Apron
Looking Downstream

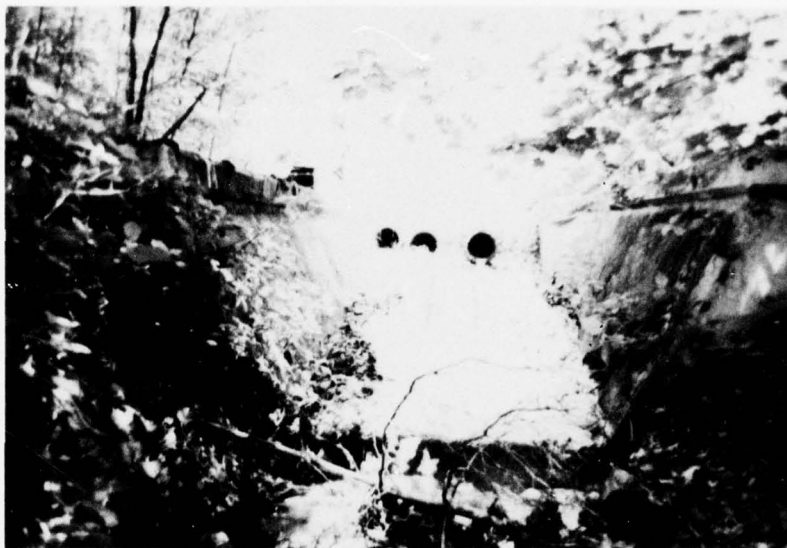
The two 20-inch diameter cast-iron outlet pipes discharged into the outlet channel. A third 20-inch diameter cast-iron pipe connected to the drainage gallery located in the core wall of the main embankment and discharged into the outlet channel. This drainage pipe was discharging water with a depth of flow of about 1/2 inch in the pipe. A deposit of orange clay was noted directly beneath the core wall drain outlet. The floor and the right outlet channel wall were in good condition. There was a vertical crack in the right outlet channel wall from the channel floor to and through the 9-inch coping on top of the wall. The crack was 1/2 inch wide, 4.3 feet high, and 10 feet downstream from the valve house. It appeared that there was an attempt to patch the crack at one time. The left outlet channel wall was severely deteriorated and undermined (Photograph H). The concrete was disintegrated for about 2 feet immediately below the valve house. The wall was undermined at the junction of the wall and the floor for the entire length of the wall. The maximum distance of undermining into the wall was 14 inches; the maximum vertical distance of the affected area was 27 inches. The concrete coping and the vertical face of the wall was deteriorated at several places to a depth of 3 inches. The 9-inch coping and the top 2 feet of the end of the left outlet channel wall was disintegrated to a depth of 3 inches. There was evidence that repairs had been attempted in the past.

G. Core Wall Drain and Outlet Works
from Downstream End of Outlet Channel

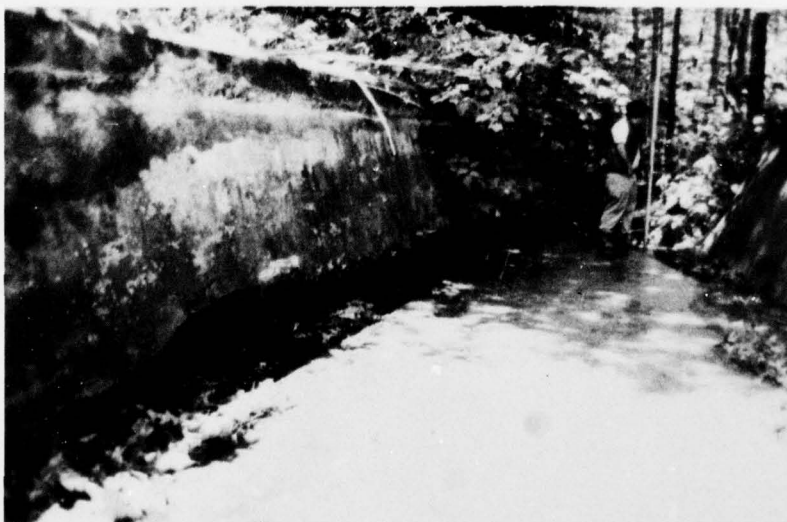
The left outlet channel wall was showing evidence of severe deterioration. Lack of maintenance may increase the deterioration and thereby threaten the stability of the wall. Continued deterioration and undermining of the wall could lead to a failure of the wall, which may threaten the toe of the main embankment.

H. Undermining and Disintegration of
Left Outlet Channel Wall from
Upstream End of Outlet Channel

(8) Repair the concrete of the left outlet channel wall.

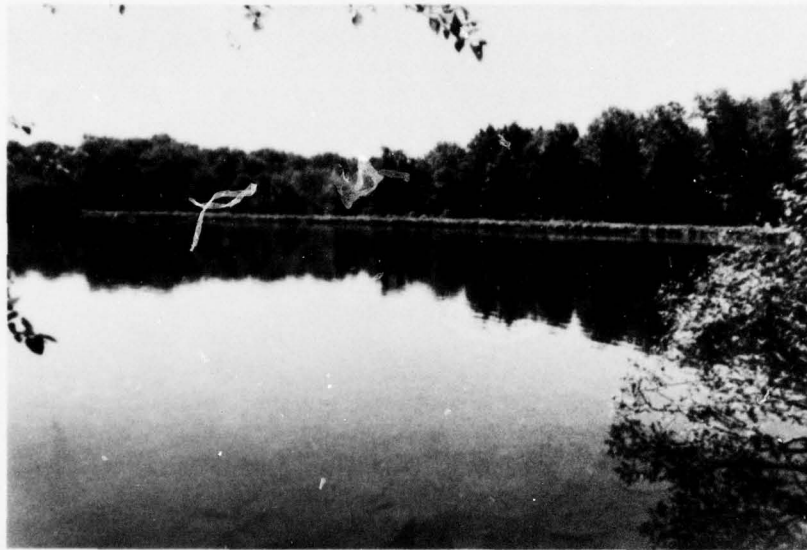
I. Upstream Face of Auxiliary Embankment from
High Natural Ground Between the Embankments

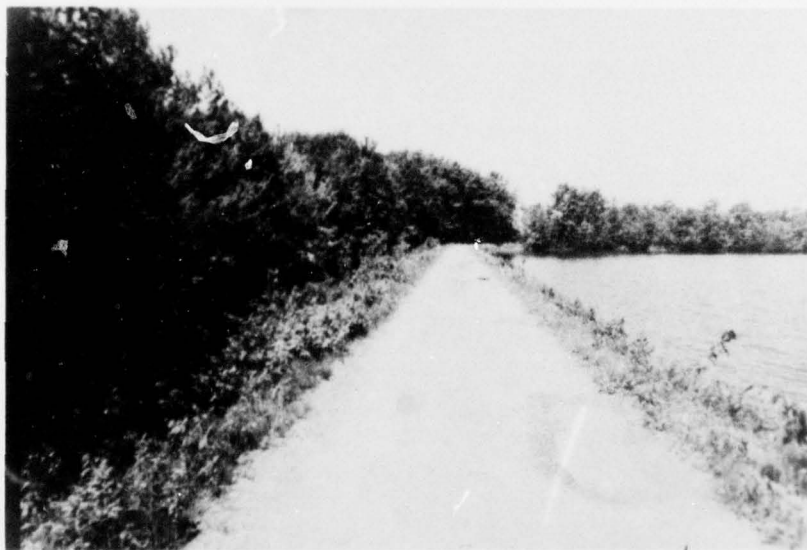
(2) Auxiliary Embankment. The auxiliary embankment was generally in good condition from what could be seen. However, 3.5-foot high brush, growing on the downstream slope of the embankment, hindered the inspection. Results of the survey of the downstream slope indicate that the slope was slightly flatter than the design slope of 1V on 2H. The area immediately downstream of the toe was covered with mature broadleaved trees with an average height of about 60 feet. The riprap on the upstream face of the main embankment is generally in place and is in good condition. There is a general cover of light brush about 18 inches in height on the upstream slope above the normal pool elevation.

J. Auxiliary Embankment
View from Left Abutment

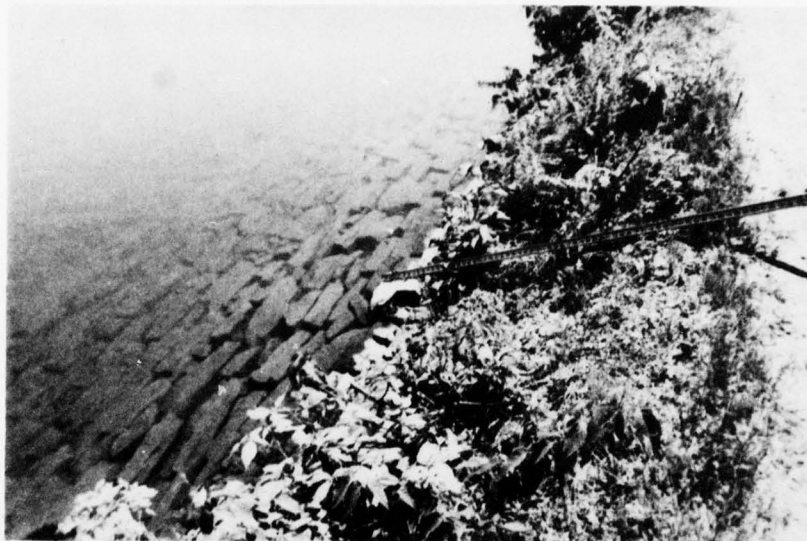
K. Riprap on Upstream Face of Embankment

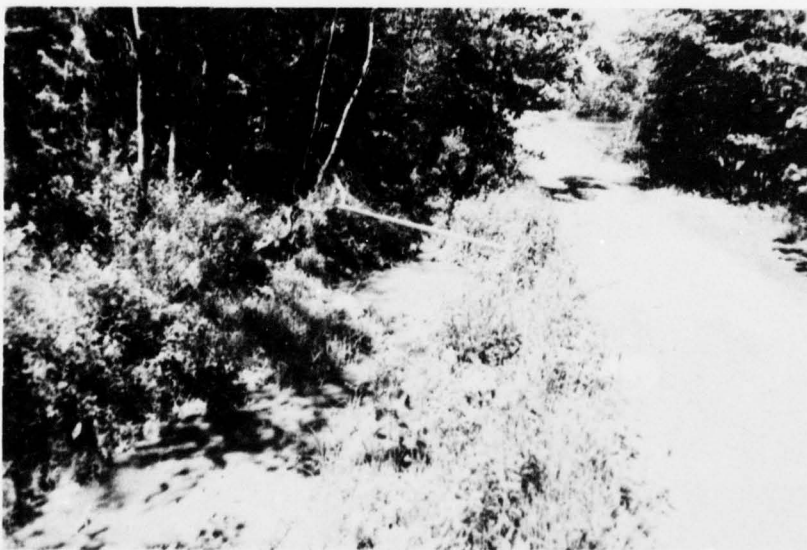
Two wet areas were observed near the auxiliary embankment. The first wet area was a general swampy area of triangular shape below the downstream toe near the middle of the auxiliary embankment. The length of the wet area along the toe was about 200 feet, and the standing water extended about 600 feet downstream of the toe. There was no outlet for the wet area, and there was no discernable flow. Old cuttings of brush and small trees were lying in the swampy area near the toe. The second wet area was a small pool of standing water at the left abutment on the downstream side (Photograph L). The pool area was 6 feet long and 5 feet wide, and the pool was 0.5 foot deep. It appeared that the pool collected surface runoff that had drained along the access road to the dam. There was no discernable outflow from the pool.

L. Wet Area at Left Abutment of
Auxiliary Embankment

(6) Investigate surface runoff from left abutment. If it is determined that the wet area at the left abutment of the auxiliary embankment is caused by surface runoff from the left abutment, provide positive drainage for the runoff.

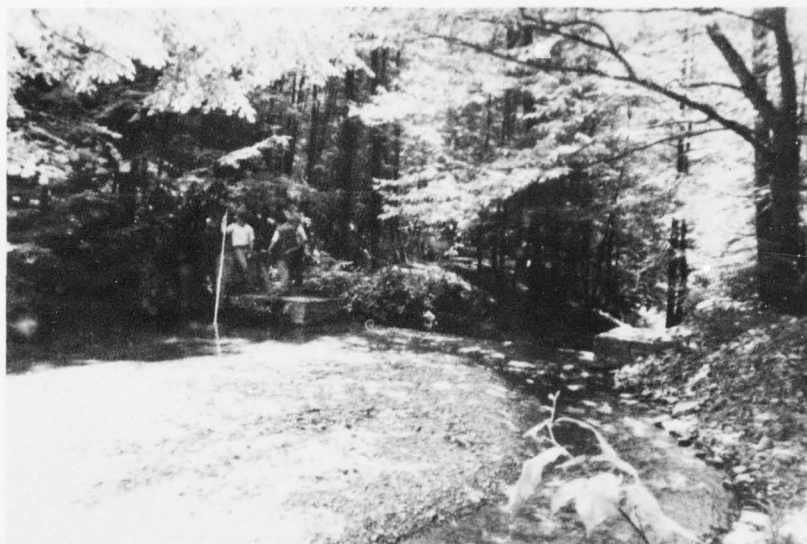
e. Downstream Conditions. A small diversion structure consisting of a 7-foot high masonry dam and headworks for a canal is located about 0.6 mile downstream of Falling Springs Dam (Photograph M). At that point, a portion of the flow from Falling Springs Creek is directed via an earthen canal for a distance of about 0.3 mile into Campbell Ledge Storage Dam. Campbell Ledge Storage Dam supplies

M. Diversion Structure Below Falling Springs Dam for
Supply to Campbell Ledge Storage Dam

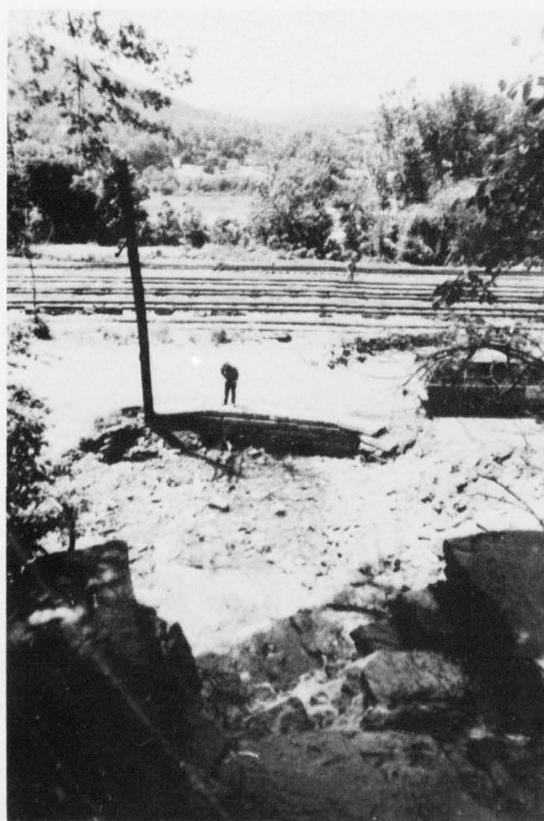
N. Outfall of Falling Springs
Creek Under Road and
Railroad Tracks into
Susquehanna River
